## Wood Destroying Organism (WDO) Inspection Report

**Client:** Smart Homebuyer  
**Realtor:** Jeff Wise Agent, ReMax Realty  
**Inspection Address:** 829 BlackHawk Rd, Olympia, WA  
**Inspection Date:** 08/24/2010  
**Inspected by:** Dan Schwartz Lic. 123456

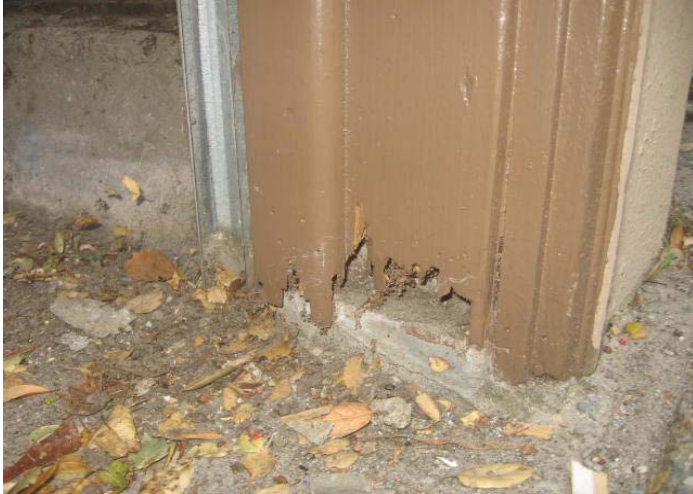
**2.1 - Rot damage was noted to the base of the overhead garage door trim. We recommend this be properly corrected.**

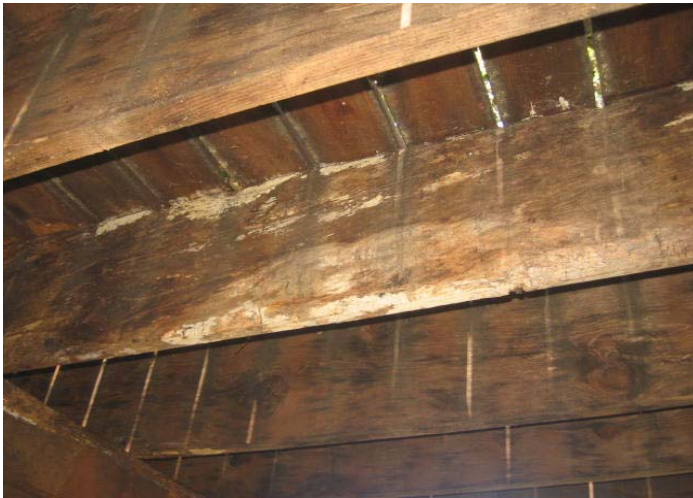
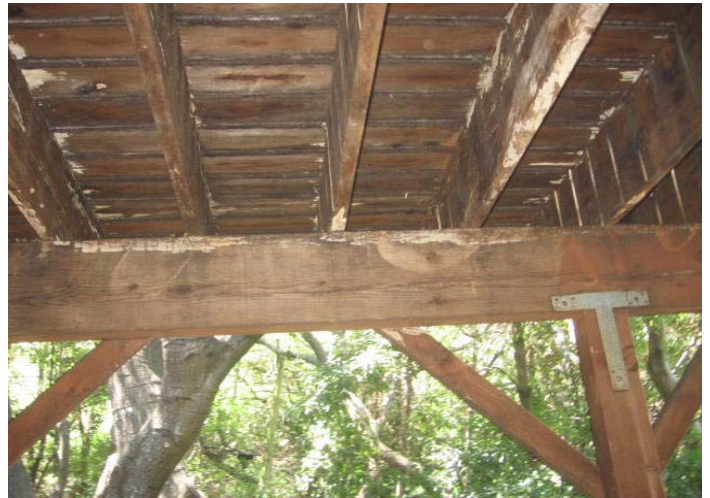
2.2 - This deck is substantially rotted. Consideration should be given to replacing the deck. Recommend contacting a competent contractor for recommendations and corrective work.

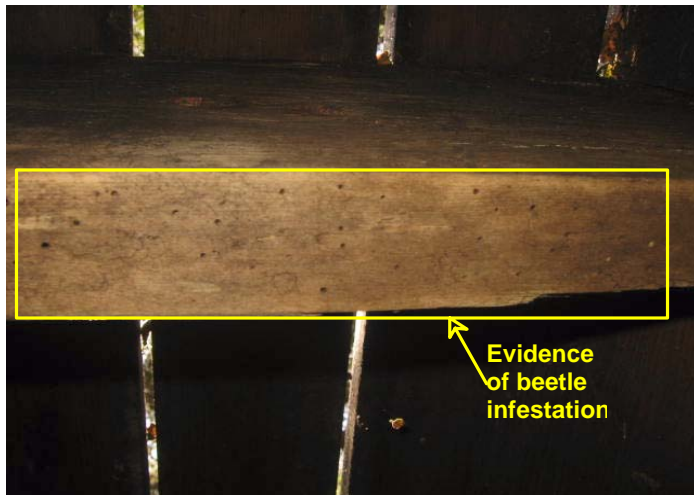
2.3 - There are also anobiidae (deathwatch) beetle emergence holes and damage throughout the deck. This problem will be corrected when the deck is replaced.

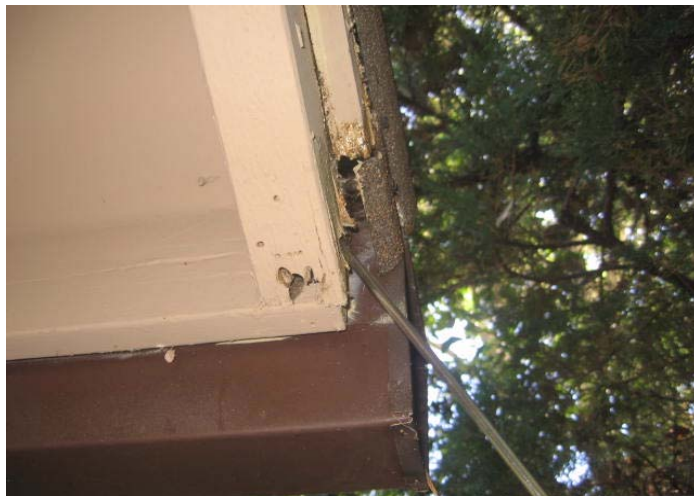
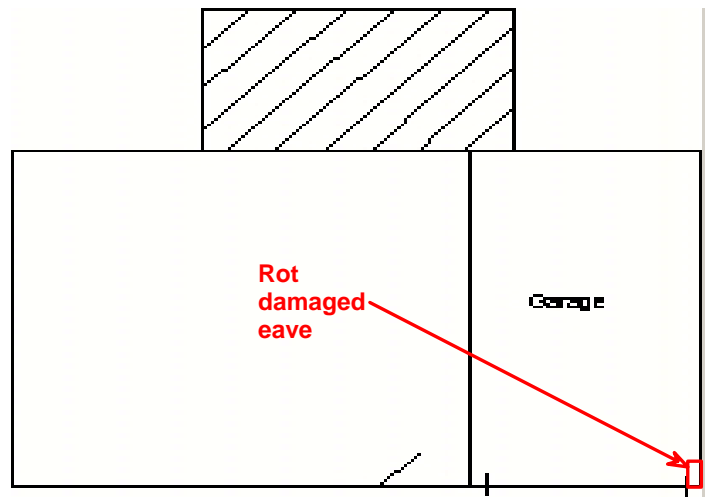
3.1 - Rot damage was noted to the eaves at the front right corner of the structure. We suggest contacting a qualified contractor for any corrective work needed.

NOTE: Repair will require removing and replacing a portion of the roof covering.

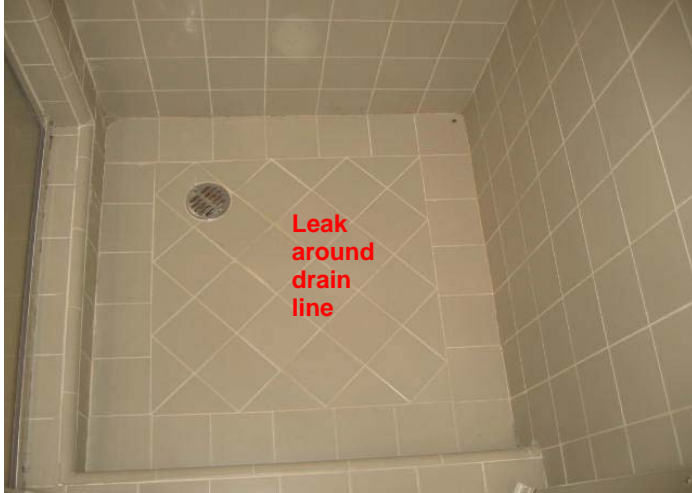
- 5.1 - Rot damage was noted to the subfloor under the shower. Repair of the subflooring will most likely necessitate the removal and replacement of the entire shower. Recommend contacting a qualified contractor for recommendations and corrective work. (See Sub Area Comments)

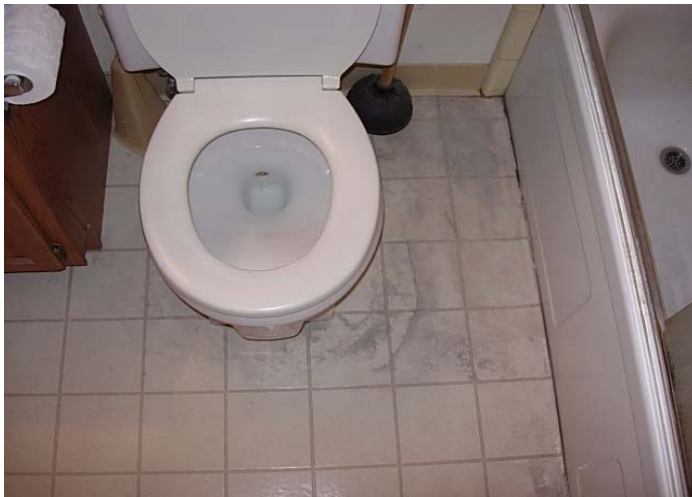
- 5.2 - Water has infiltrated beneath the floor covering as evidenced by damaged underlayment. The cause of the damage appears to be overspray. We recommend having this floor repaired by a qualified flooring contractor.

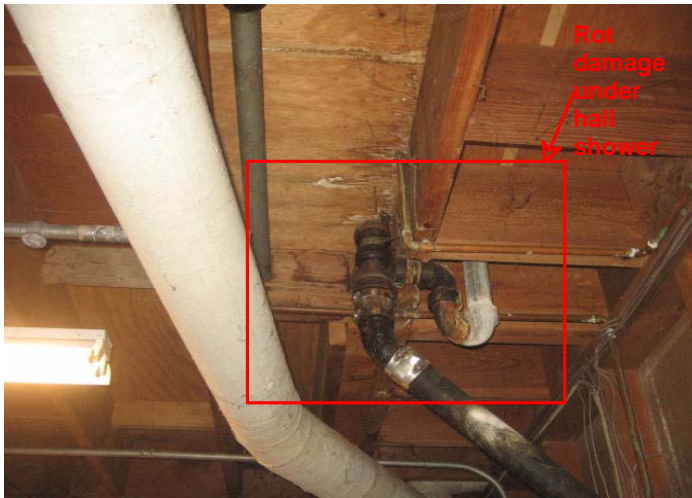
11.1 - There is rot damage to the subflooring under the hall shower pan as a result of an active leak. Recommend removing all damaged wood, replacing as necessary, and treating the adjacent area with an approved fungicide. Repair will most likely require the replacement of the stall shower.

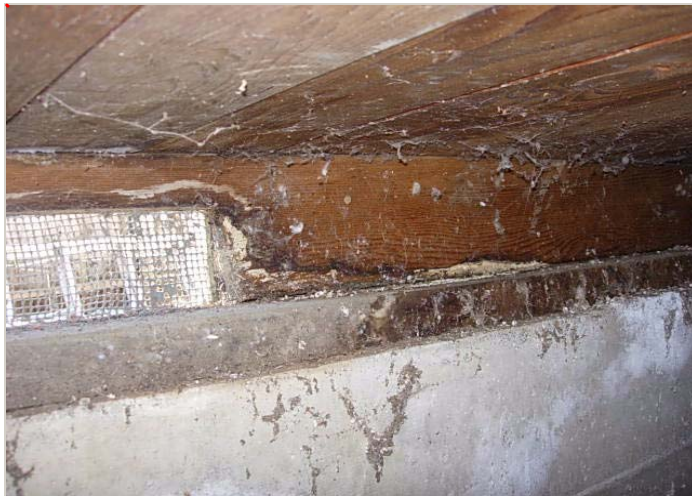
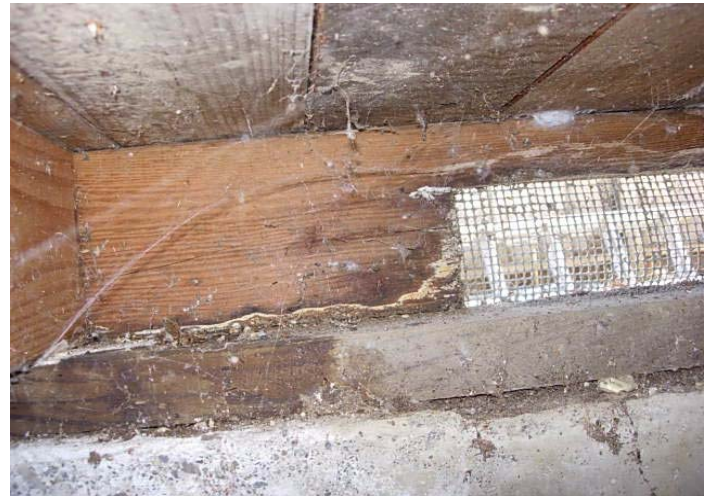
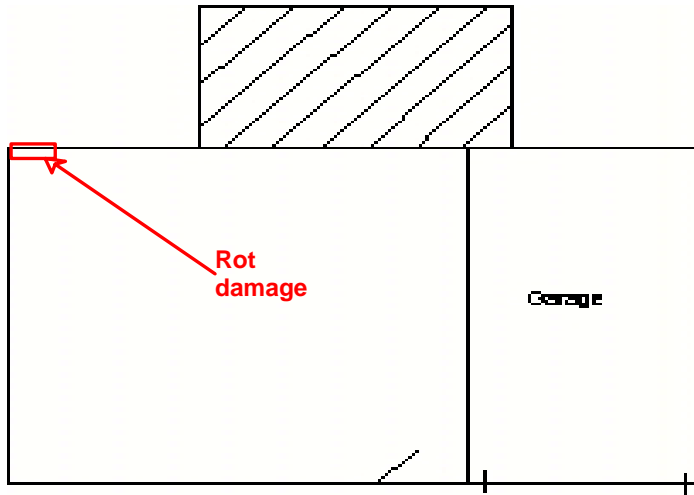
11.2 - There is rot damage to the rim joist at the left rear corner. Recommend removing all damaged wood, replacing as necessary, and treating the adjacent area with an approved fungicide. This repair will require removing and replacing a portion of the exterior siding.
